## *Section 2*

### *The Clock Serial No 3824*

## 2. The Clock

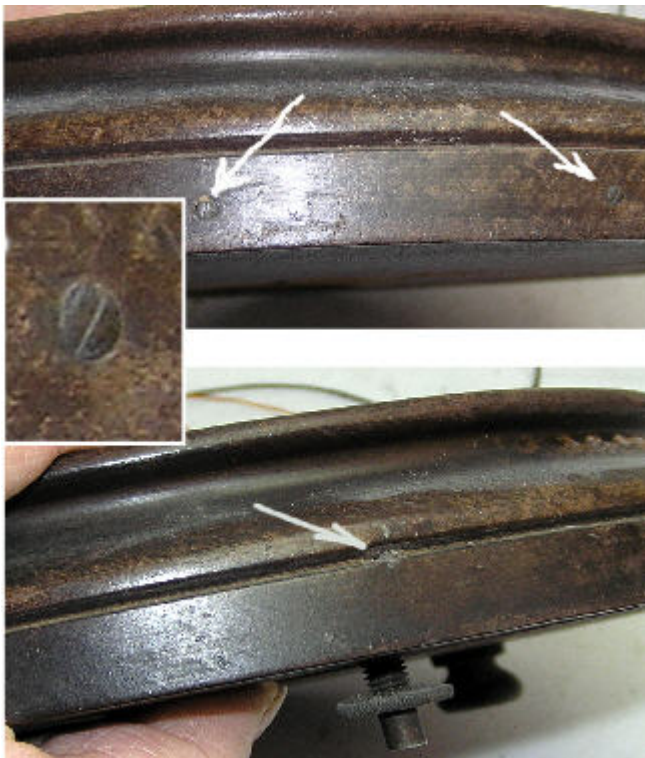
**Photo 2/1**

The original brass nails are still in situ at the front (**Photo 2/1 and inset**) and the remains of the wire can still be found at the back where it was - retained in a small hole, shown in the insert photo.

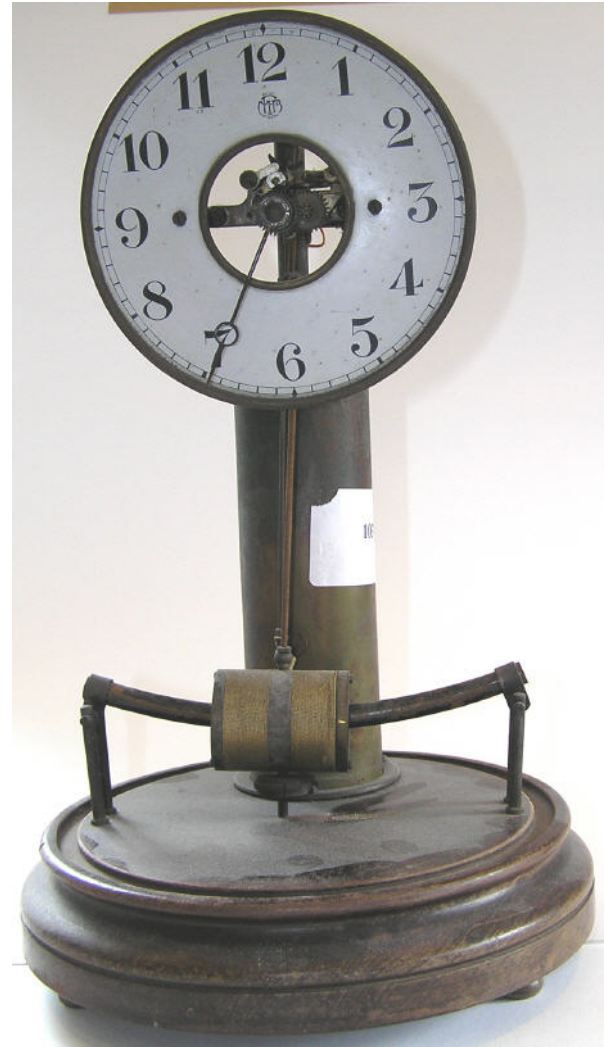
**Photo 2/2**

This clock (**photo 2/2**) is an early version of the "Tall Movement" under a dome, characterised by a cotton bound bob, moon hands, movement made from square section brass direct onto back plate, single driving pawl with separate retaining pawl, and over-slung damper. Later models have multi-plate movement with pillars, fine spade hands and metal clad pendulum bob.

The dial is still in reasonably good order and should look good when the brass is cleaned **(photo 2/2)**. It should not need re-painting. The hour hand has been broken and will need to be replaced.

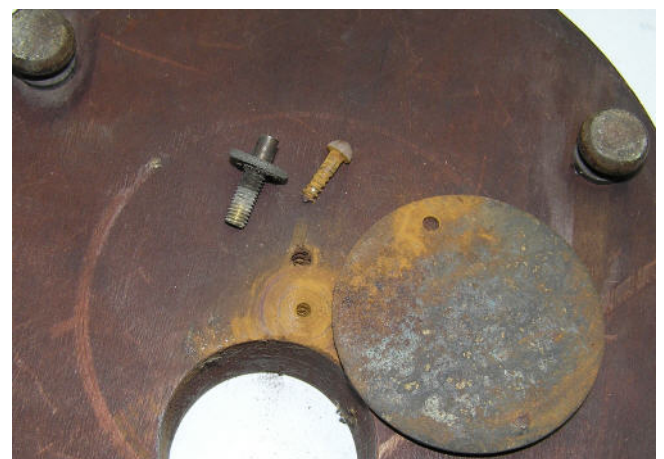
**Photo 2/3**

The name plate was lost early on in the clocks career as there is no discernable mark left on the wood. The original battery on these clocks were 1.5 volt Flag cells that sat up in the tube inserted through a cover in the base (**photo 2/3**). The unfortunate thing is that the battery often leaked acid and was left over the years to corrode the brass tube and retaining steel door.

This could be so bad as to eventually eat through the tube and show initially as a mottled surface which then later grows to more sizeable marks often turning green and in the worst cases leave gaping holes.

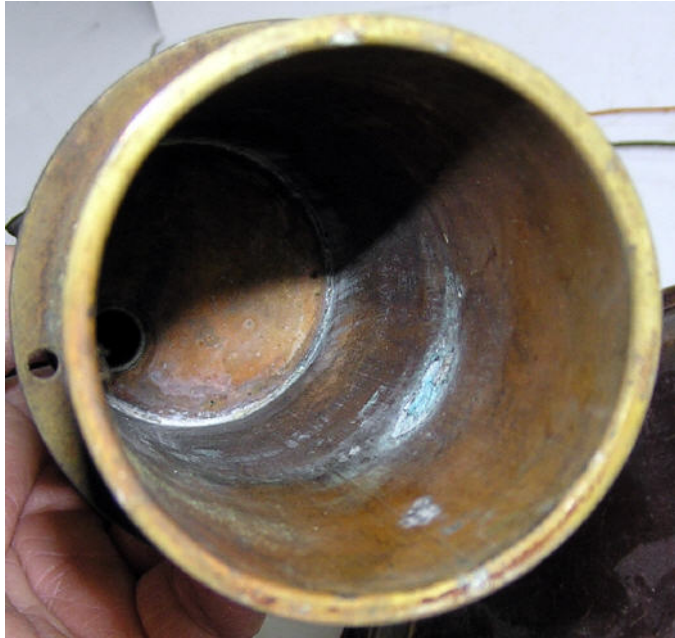
**Photo 2/4**

pendulum coil, the power had to be routed via a loop piece of silver plated wire across the gap caused by the silk suspension block. It looped from the top of the frame to the main iron rod of the pendulum. This particular clock is quite badly corroded on the inside but only shows the mottling on the outside. **(photo 2/4)**. We'll discover more after we start cleaning.

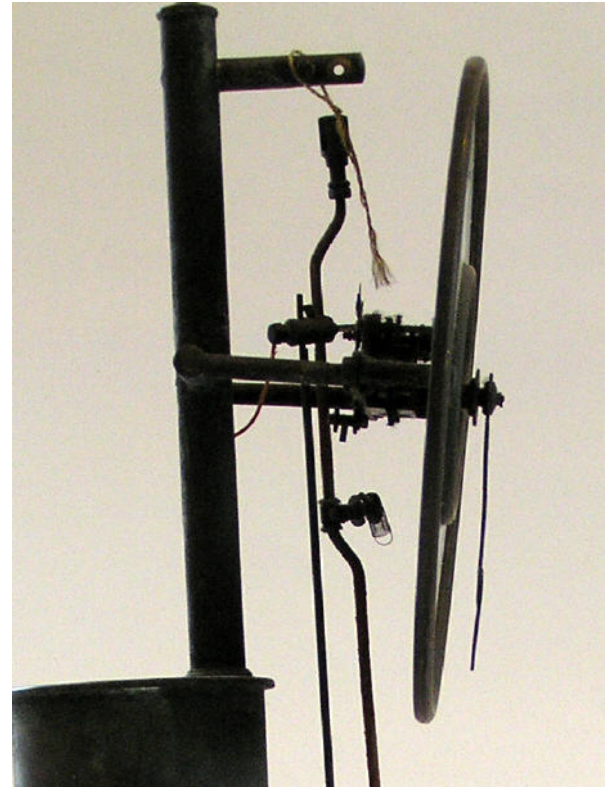
**Photo 2/6**

The movement retaining pillars are loose and hanging down at about 10 degrees and will need to be corrected **(photo 2/6)**. In this case someone has tried to attach the battery directly to the pendulum via the contact pin assembly. This is a bad idea. It would badly affect the amplitude of the pendulum swing

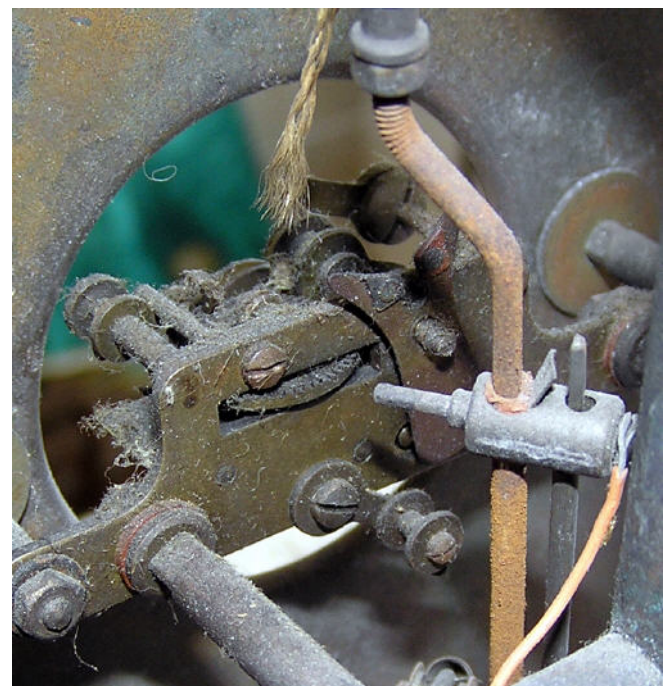
**Photo 2/7**

**(photo 2/7)**. The hex head bolt is missing from the back of the assembly.

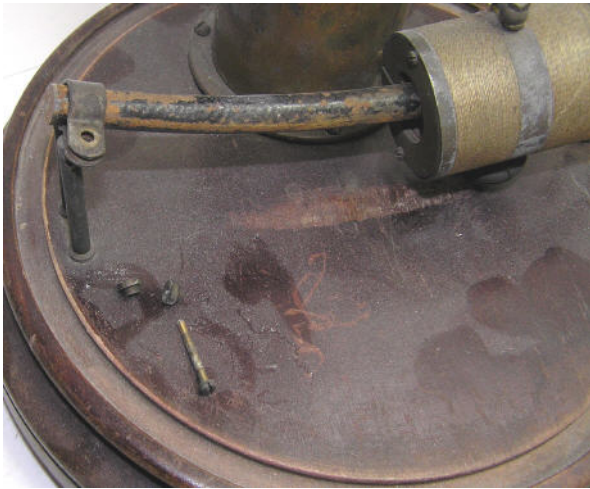
**Photo 2/8**

Also note in this photo the general condition of the clock. What isn't gummed up with oil and dirt is covered in rust. The base has been marked by the pendulum since the suspension has broken. This will need to be repaired and the whole base French polished **(Photo 2/8)**

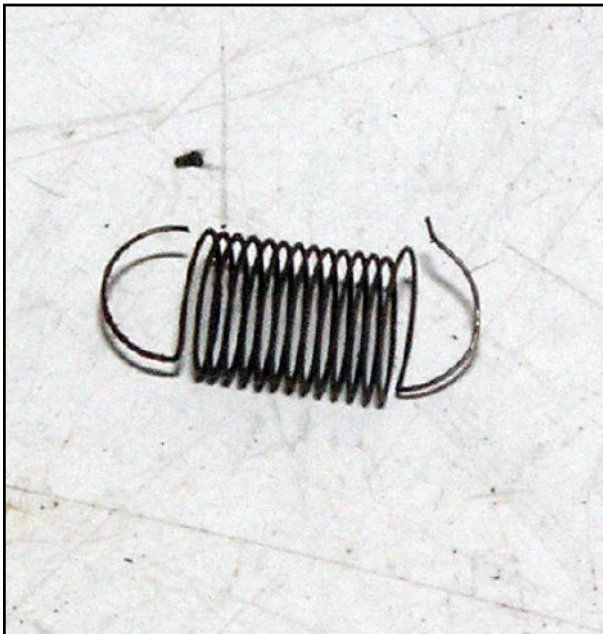
**Photo 2/9**

The Isochron spring is still intact and is hanging at one end only. It looks to be in good condition and is re-usable (**photo 2/9**). The Silver contact spring, however is completely missing and will be replaced.
