The restoration of David Perret Wall Clock Serial No 2948

By Brian Scott brian@hectic.name January 2023

This article describes some of the history of David Perret clocks and the restoration by the Author of a wall clock by David Perret made around 1905.

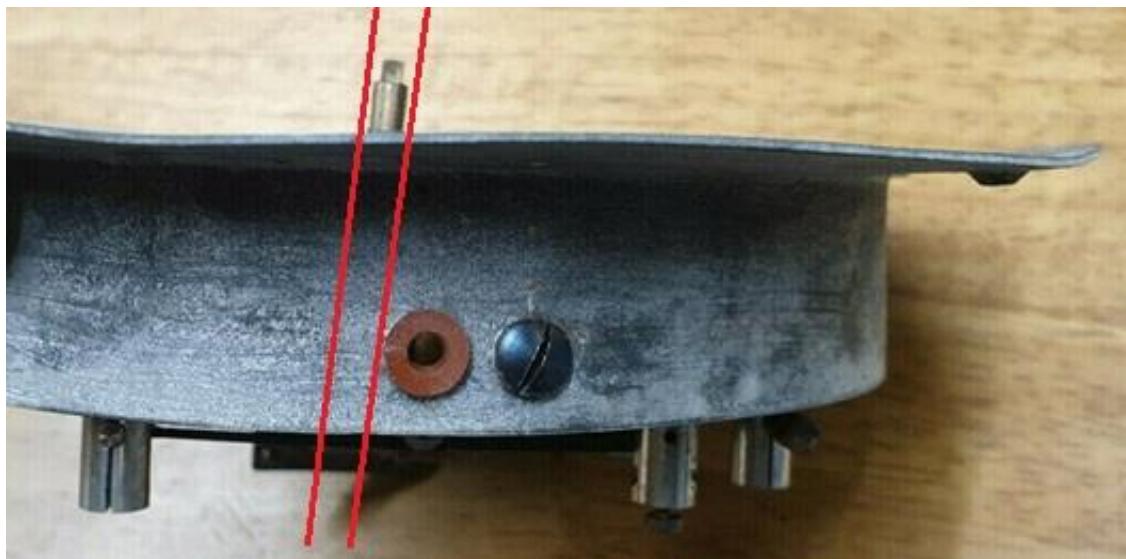
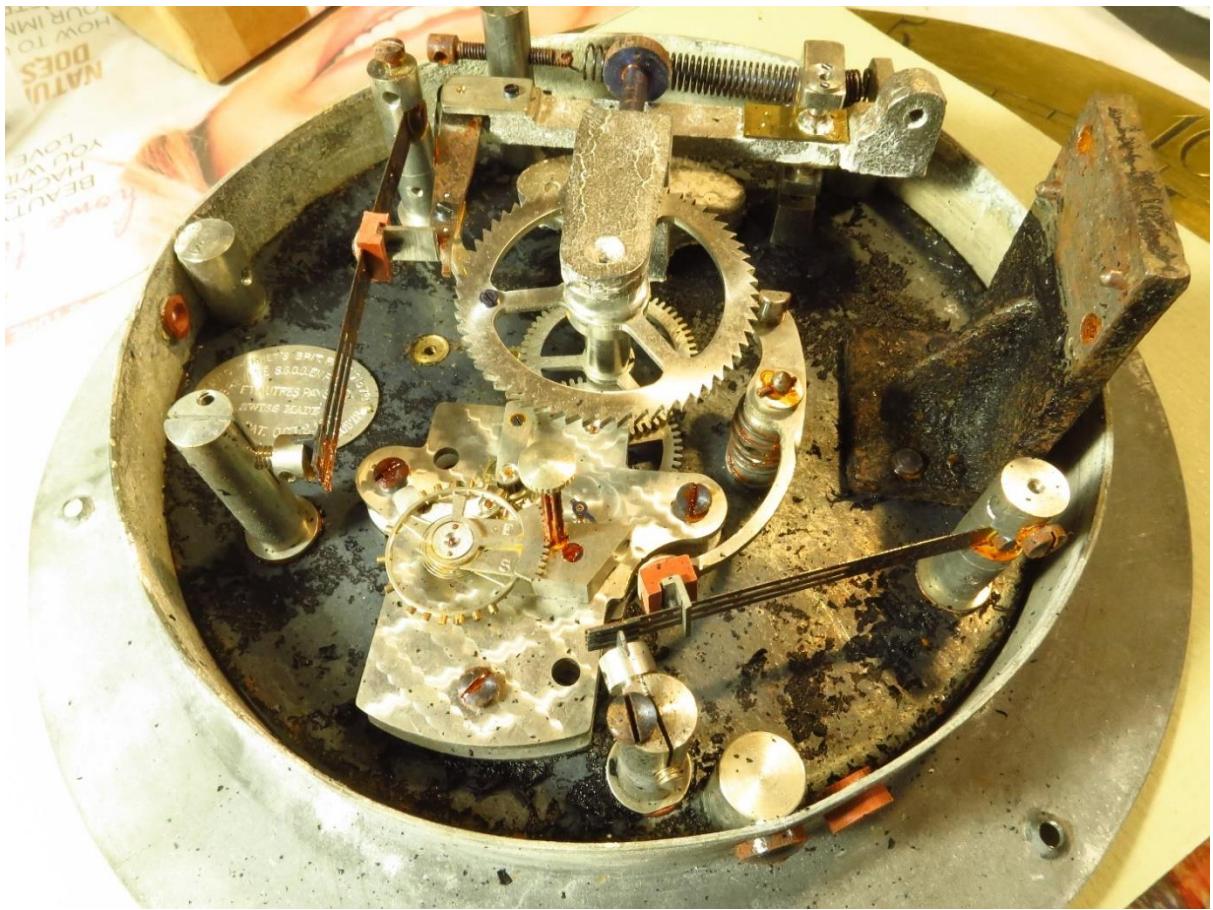
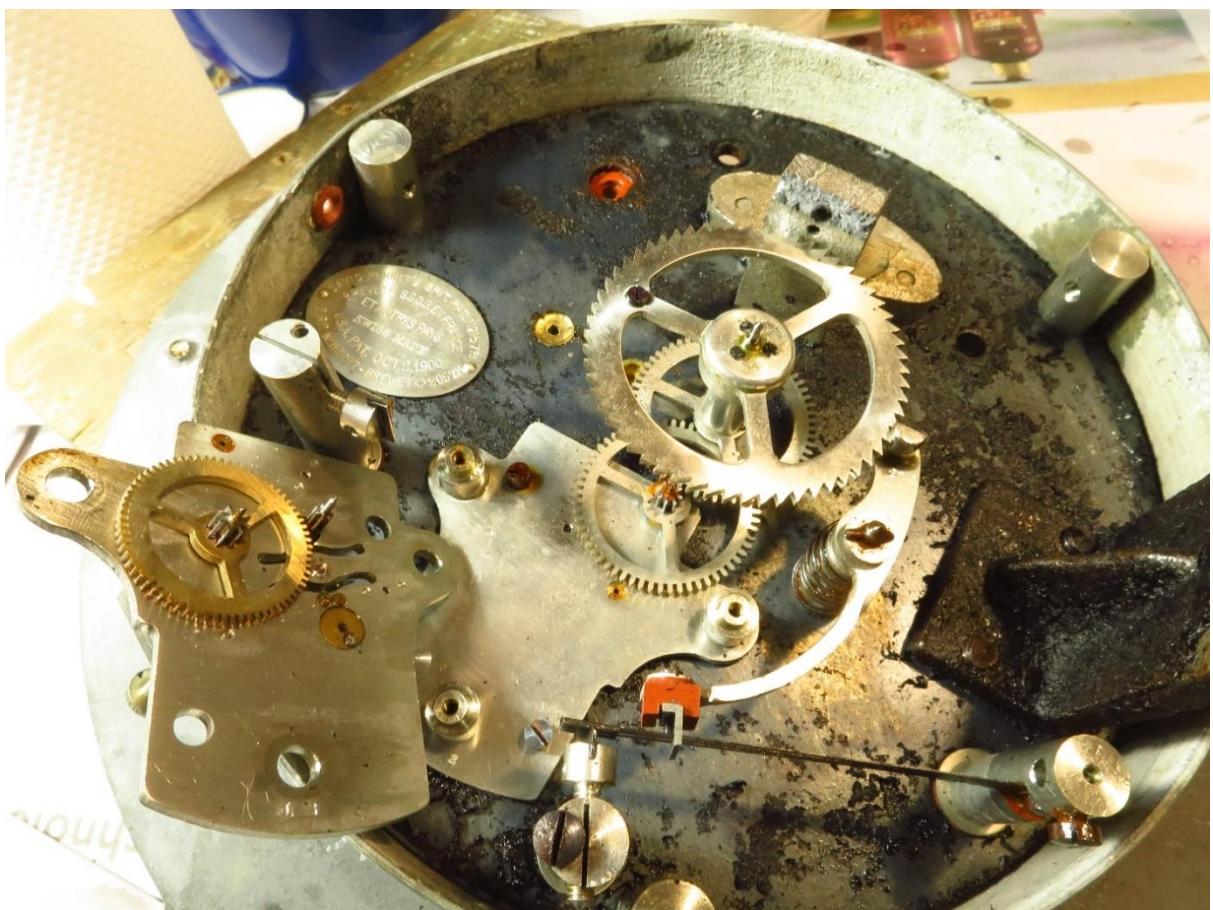
- 1 There was light and heavy rust on some of the iron components – including some of the pivots.
- 2 The movement was dirty with flaking paint and general dirt.
- 3 The solenoid was missing
- 4 The main minute shaft was well out of alignment and it was thought to be bent
- 5 The die cast components exhibited growth in in their dimensions and showed cracks.
- 6 The main solenoid operating beam at the pivot point had been repaired in the past with brass re-enforcing plates.
- 7 The pin and short lever on the solenoid operating beam was distorted and would not engage the serrated teeth on the main minute shaft. The photographs show the condition on arrival.

The main minute shaft was not bent as it appeared first but was angled because of growth of the die cast bracket supporting the pivot of the shaft. During disassembly the cast bracket broke due to the extensive cracks and embrittlement present.

The damage to the 1 minute shaft support bracket, due to the “zinc pest” degradation problem, meant that a new support bracket had to be fabricated. The steps are shown in the pictures below.

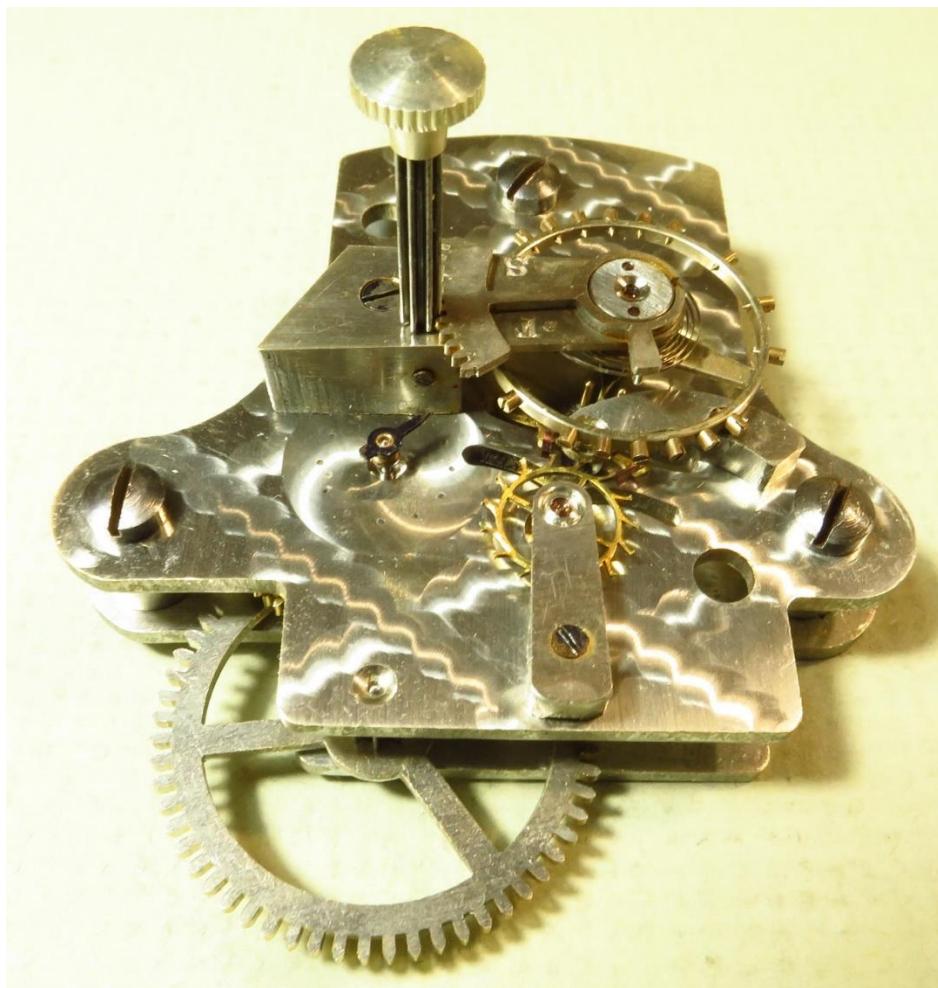
Pivots were fairly corroded on the pallet fork
