## *Restoration of Bulle Clock Serial Number 201191.*

Early Battery Clock Parts & Restoration

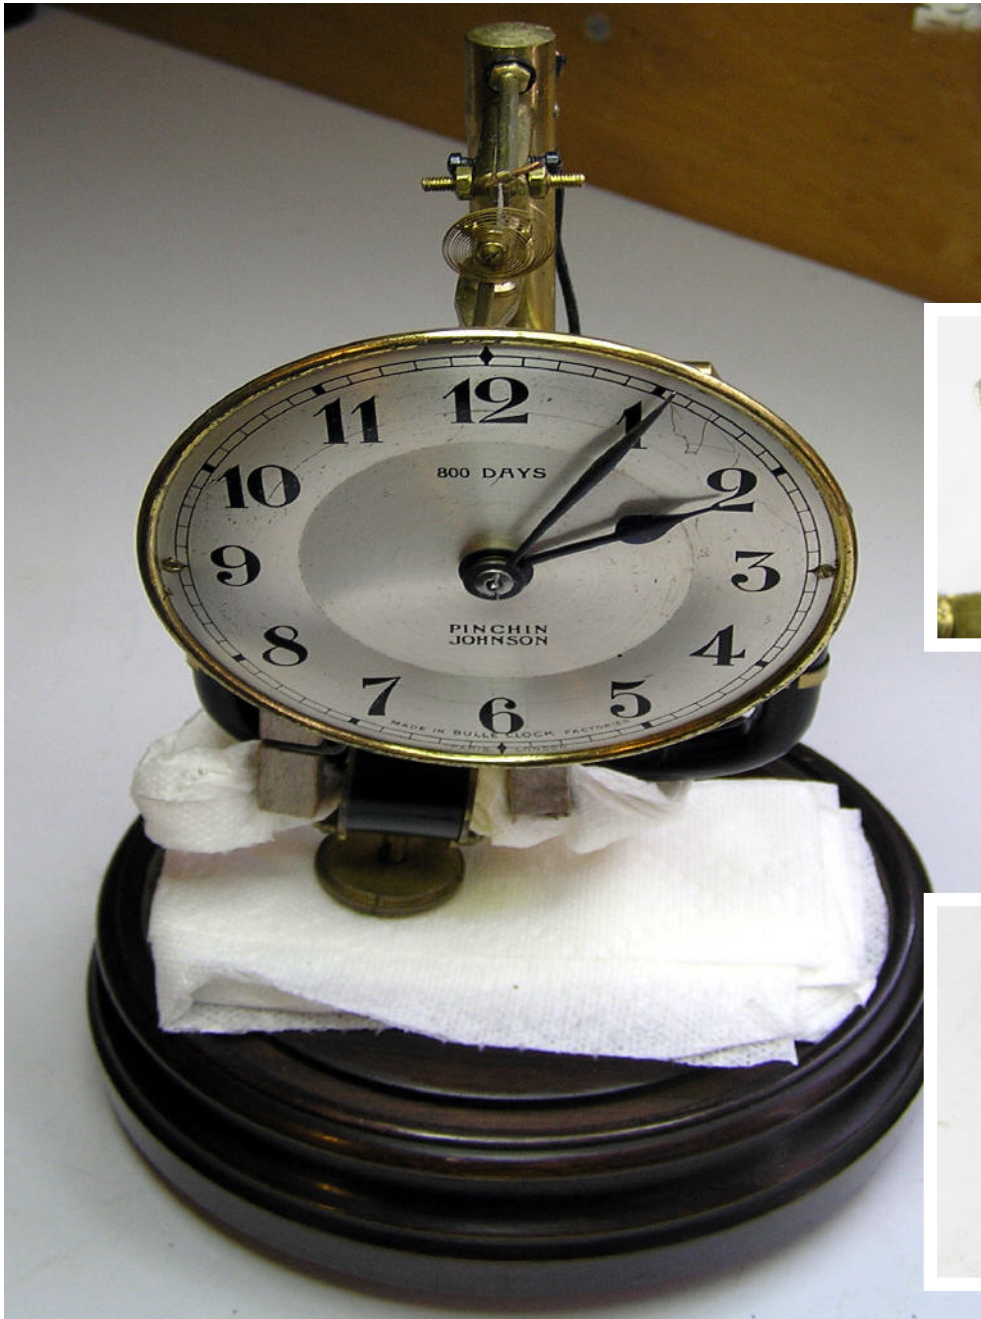
*A short Bulle movement (clockette) on a round mahogany base. The clock will be shown at various stages of restoration.. The photo below shows the damaged fork.*

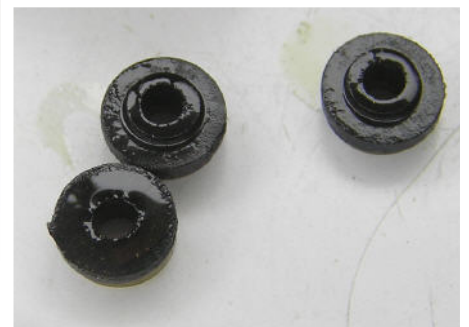
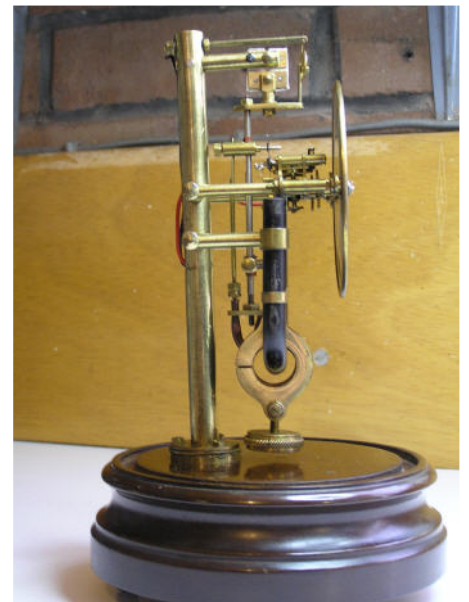
*The clock has at some stage been subject to excessive oiling as can be seen in the oil soaked insulating bushes which will now need replacing. The movement also seems to tilt at an odd angle?*

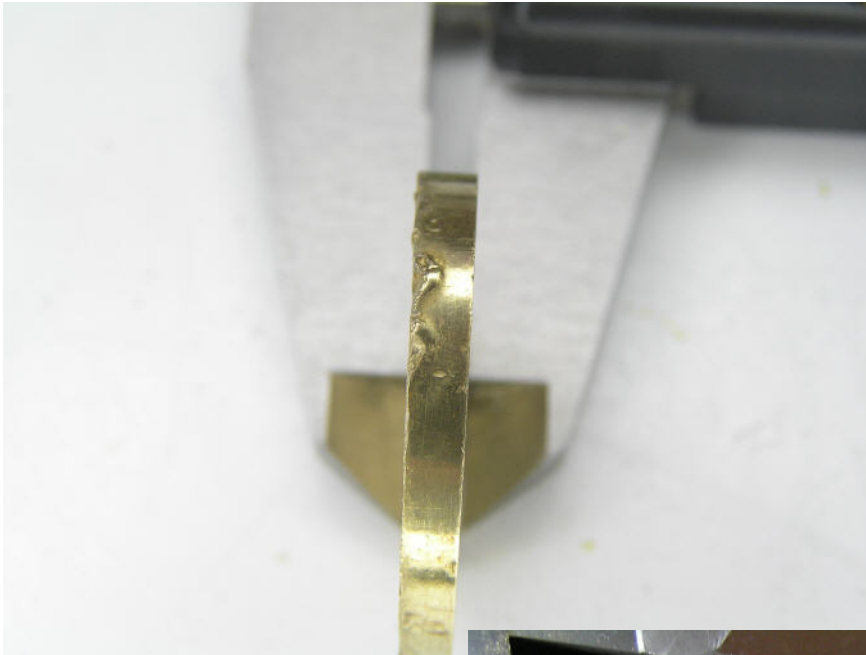
*The thick spacer under the column turned out to be wedge shaped and pretty battered as can be seen in the photos. I hope you can see that the spacer thickens as it reaches the damage. The thickness was measured at 3.1mm on one edge and 3.55mm on the opposite side. No wonder the column leaned out at an angle. Fortunately all the damage was on one face only.*

*The opposite face was clean and square. So I mounted it on a mandrel in the lathe and resurfaced it parallel.. I also machined the perimeter to remove the bruises..*

*The resurfacing took off 0.5mm, so the thickness is now an even 3.0mm. We'll have to reassemble the column to make sure there is still enough height for the pendulum to swing freely.*

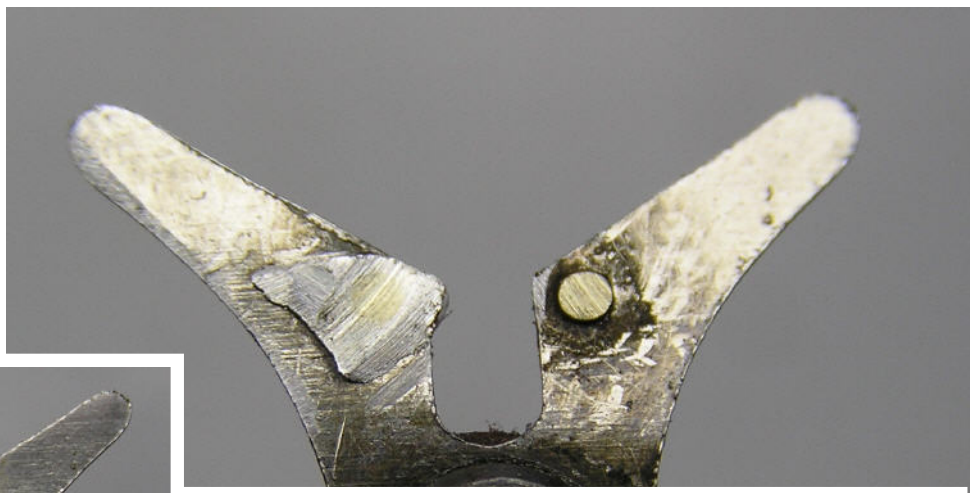
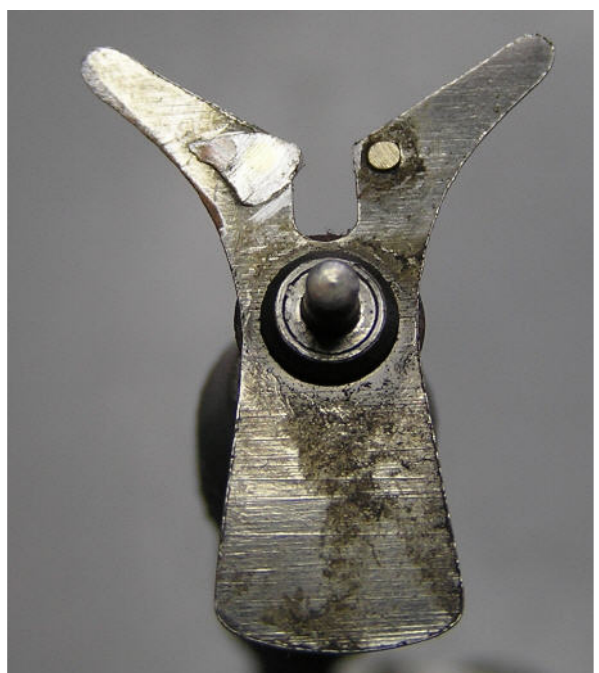
*These photos show the state of the fork. Not only were the Silver and Fibre contacts damaged, there was also a thick oily sludge everywhere. I have ground the rivets down slightly here so that they will be easy to punch out.*

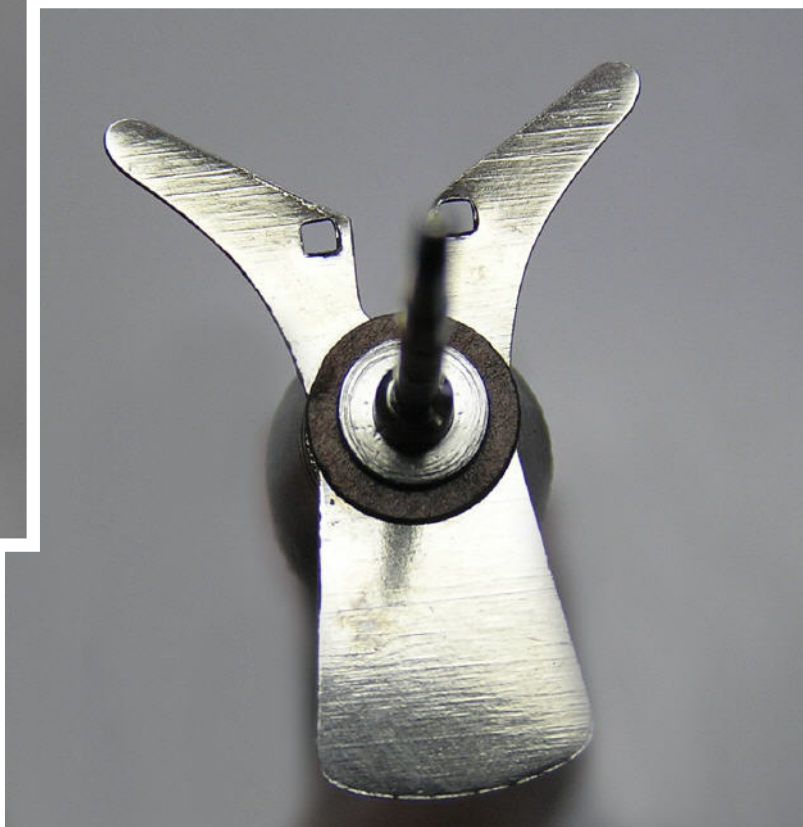
*The bottom photo shows the fork after the rivets have been removed using the Staking set. The whole fork and arbour have been cleaned and polished ready for the new contacts to be riveted in place. Note how the original holes were square punched when manufactured.*

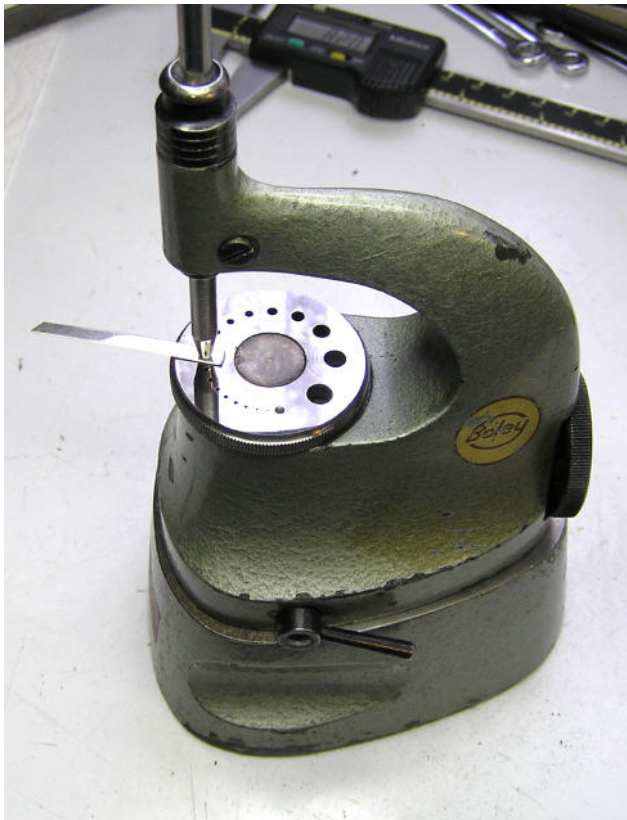
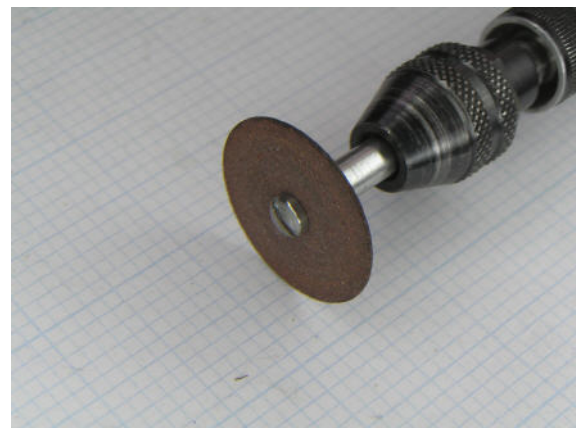
*The first stages in making the replacement fork contacts. I use hard fibre washers which are then roughly cut to shape and thinned before fitting. Once in place I can finely shape with a disc cutter and needle files. The edge is then polished smooth. The silver I obtain from a jewellery supplier in strips ready sized for the job. The hole is then punched on the staking tool. The disc cutter is shown below. It is a useful tool if used carefully with an eyeglass.*

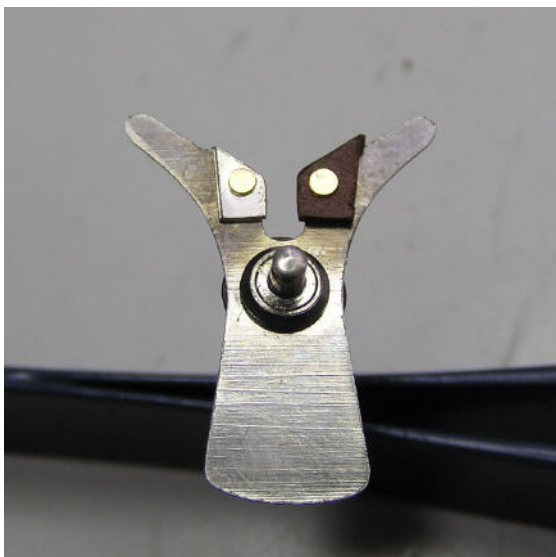
The contacts are now riveted in place using the staking tool. The finished fork is seen below.

All that's left is to clean and polish the contact faces so that they are smooth are free of burrs etc. The fork is then cleaned again and checked for continuity.

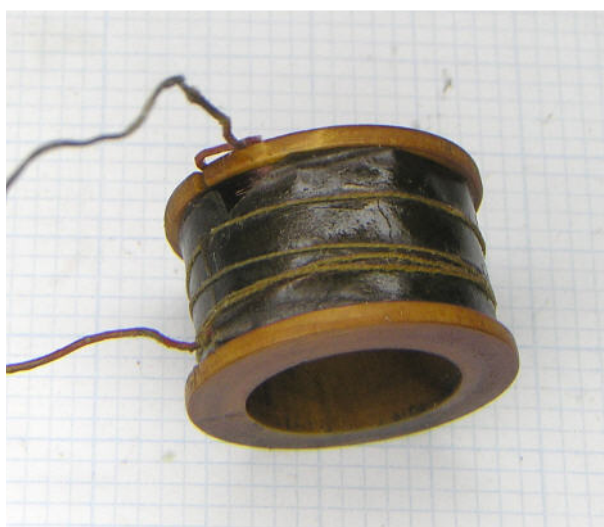
*As can be seen from the photo on the right, the coil seems to be dead, in that I could not get a resistance reading at all. After checking all other possibilities (including the meter) it must be assumed that the coil has a break somewhere in its windings. The probable areas are the joints where the 42 gauge wire is soldered to the heavier gauge contact wire. Hopefully this will be at the outer end and not the inner!*

*Thankfully the former was the case and it is an easy job to clean and re-solder the connection.*

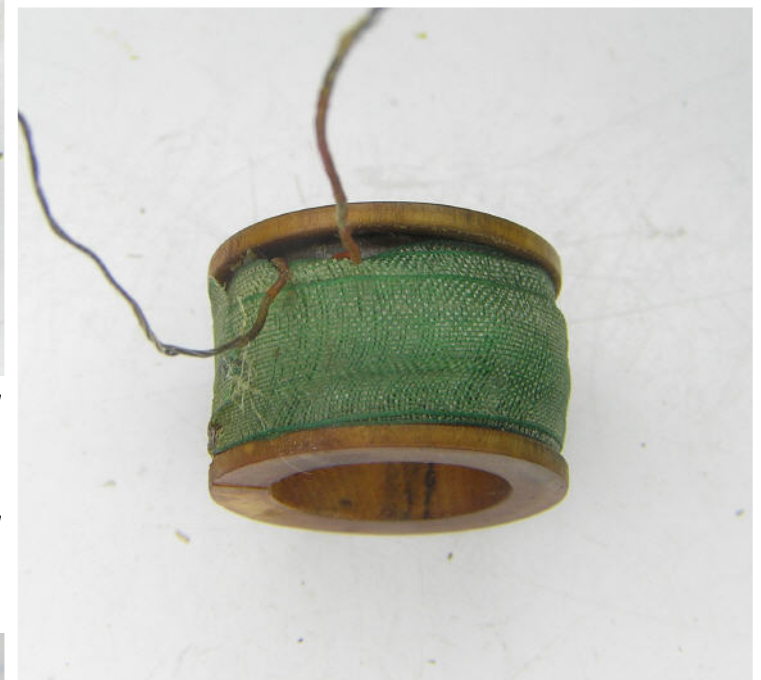
*The coil after re-soldering the join. The original wax paper was re-used to cover the joint but the old string fell apart so I had to resort to some new.*

*The original green ribbon was also re-used and put back in place as near as possible to its original position..*

*The coil was then checked again for a good resistance. The meter read a steady 1240 Ohms.*

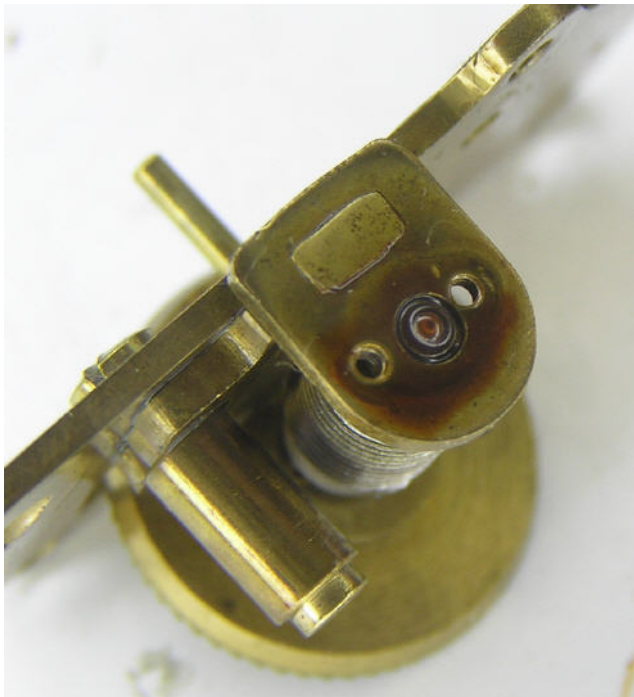
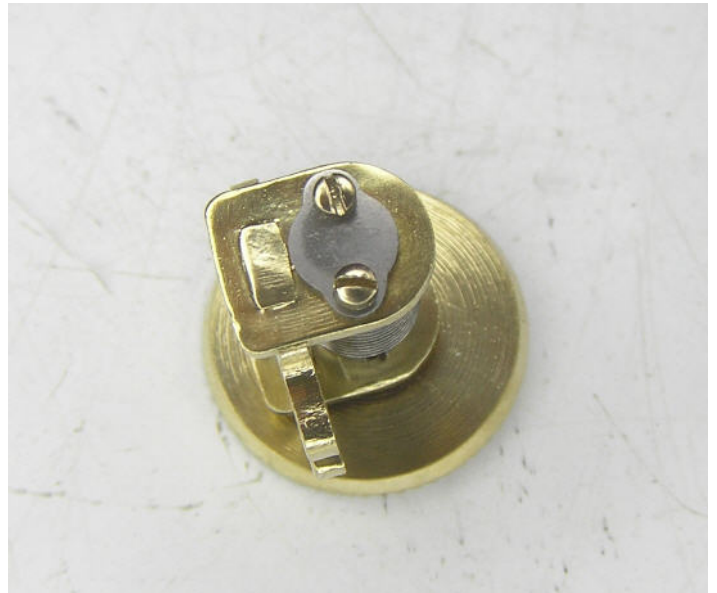
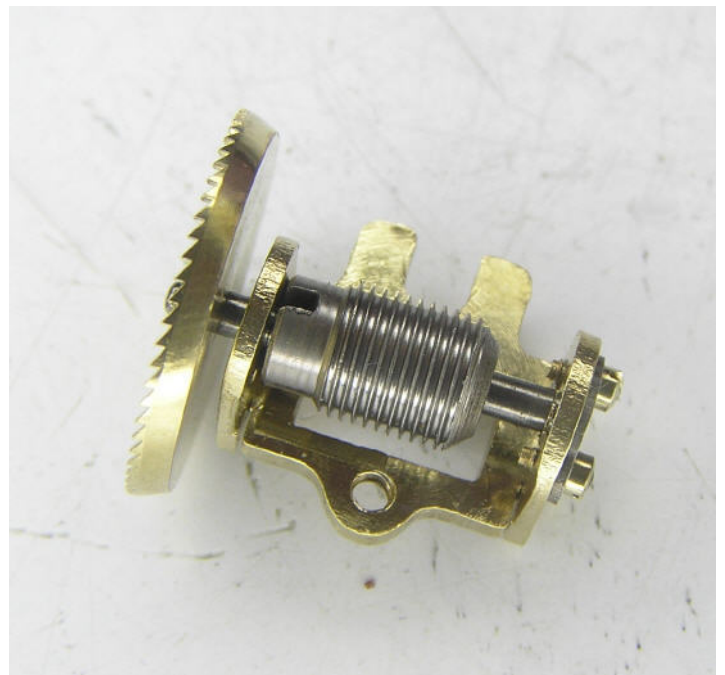
*The photo below shows the state of the count wheel assembly. It was thick with oily sludge. The photos at right show the the same assembly after cleaning. The clock coil and magnet must have had a hard job trying to overcome the drag created by this mess.*
