Horologix

*The place to come
for all your Bulle
and Eureka restora-
tion parts.*

Bulle Clock Serial Number 274481.

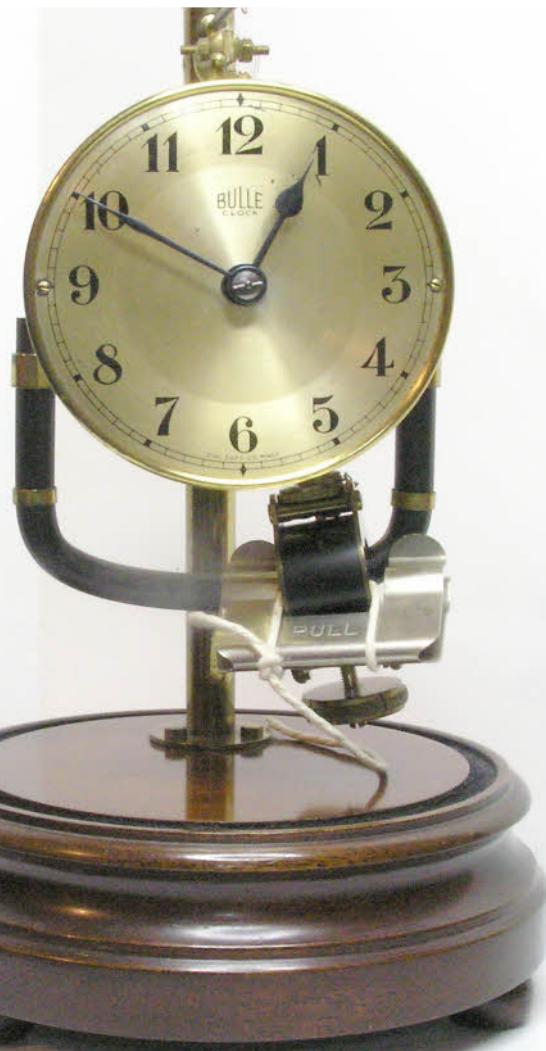
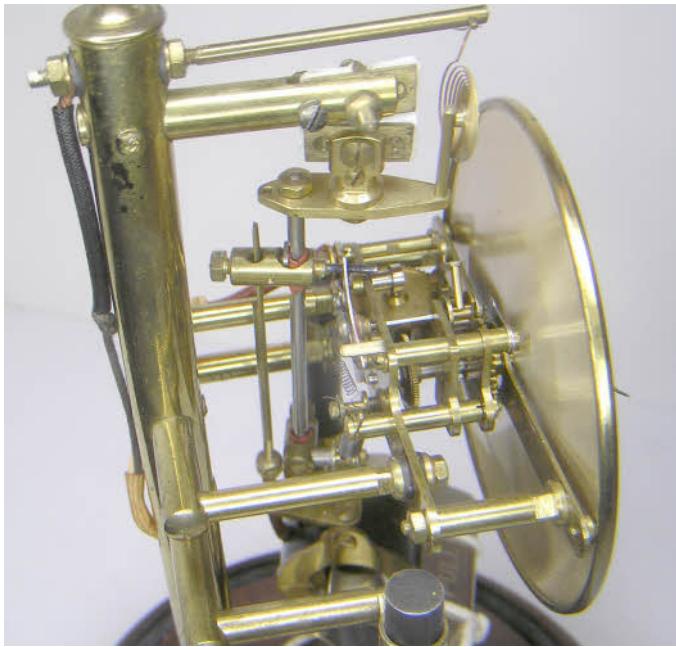
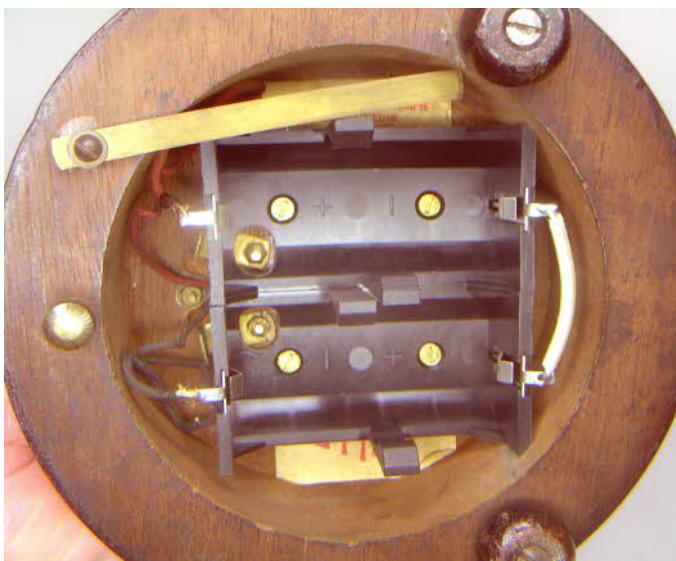
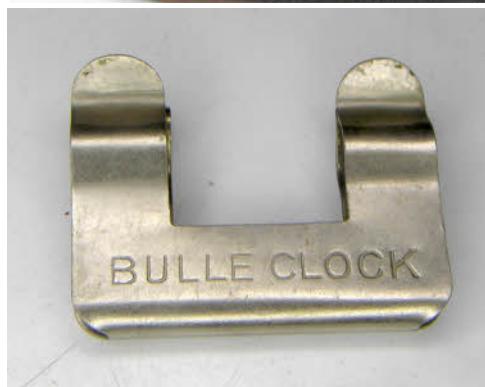
A Bulle Cloclette on a round mahogany base with a rare pendulum spring steel retaining clamp. The base is in very good condition and will only need a polish with some good wax. The most obvious problems areas are the suspension and the battery compartment. The suspension will be replaced as per usual and the battery holder removed to reveal the Bulle label.

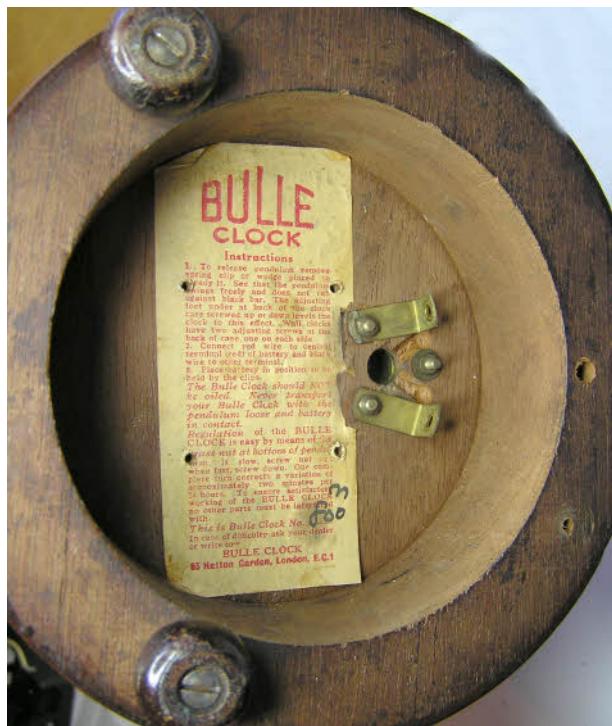
The photo above shows the battery compartment below the base with the carrier removed. The brass strips are also not original and will be removed. The label can now be seen in full.

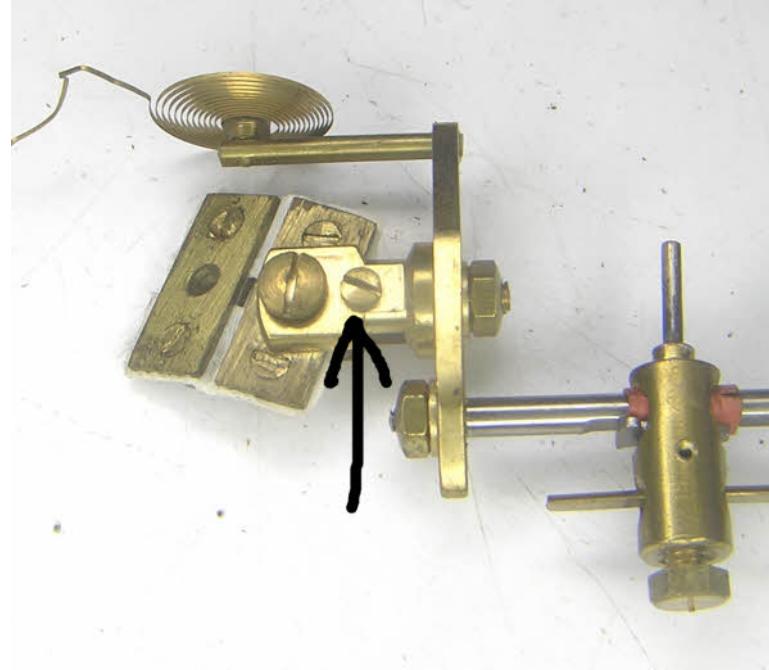
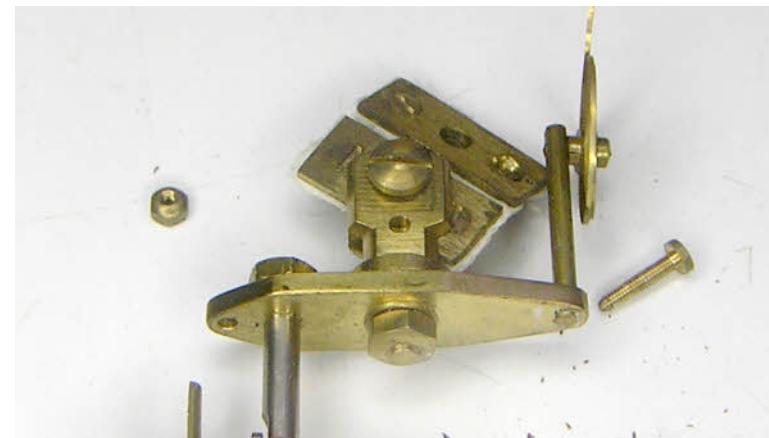
The two photos on the right shows the small bolt and nut which at first glance seem to be doing nothing. And to be honest even at second glance, I can find no real reason they should be there. The only two I can conjure up are a) To stop the pendulum from swinging too far forward or back. b) To adjust the gap in the lower suspension block. Both reasons are weak but in the absence of confirmation from the manufacturers, we will never know.

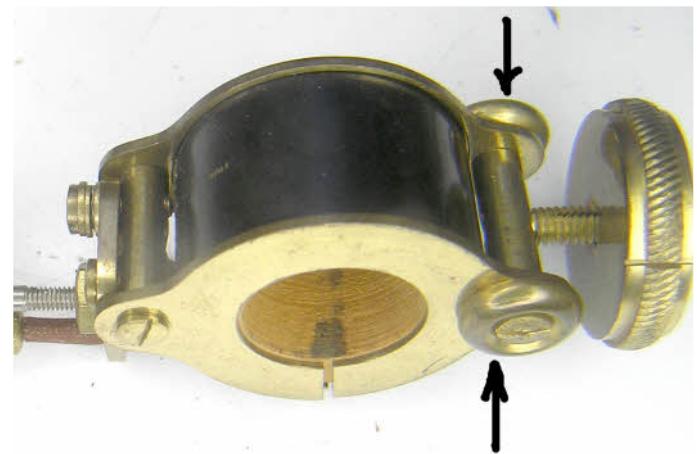
This last photo shows the two decorative washers placed at the bottom of the coil casing. There are a number of designs seen on these clocks. These happen to be Donut shaped. You sometimes find a pair of flat washers back to back.

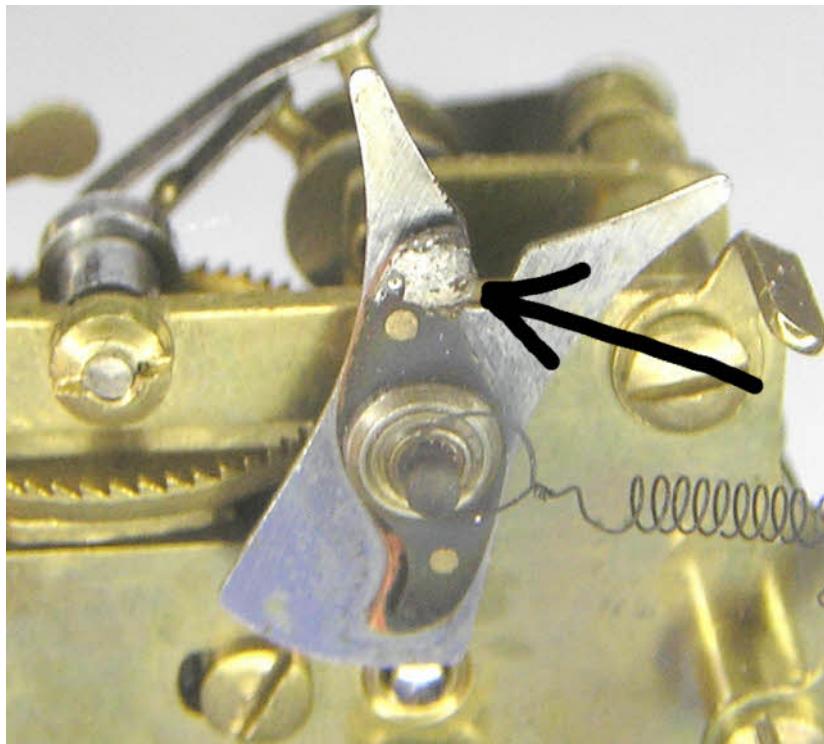
This looks pretty nasty. The silver contact has a large blob of solder on the contact face. The only reason can be that the silver underneath has been worn down. We will see when it is removed. If the silver is badly damaged or worn then the whole fork will need to be replaced because, contrary to the commonly held belief, the silver contact is not symmetrical in its "S" shape and cannot be turned upside down and re-riveted back in place.

The fork with the solder removed and the silver flattened slightly to remove the small amount of wear. This will work perfectly well for the next twenty years or so.

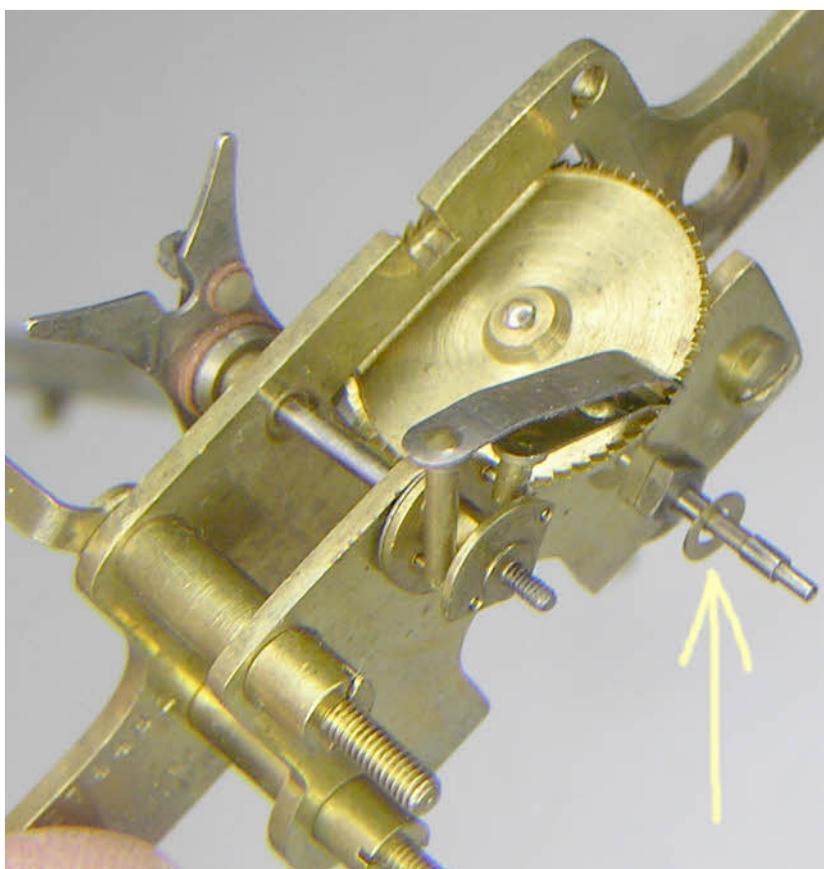
This photo shows the movement almost completely disassembled bar the second plate and count wheel. Note the washer found on the small minute wheel stub arbour. It shouldn't be there and I could find no reason why it was fitted. The wheel work was repositioned and all turned freely. It will be removed.

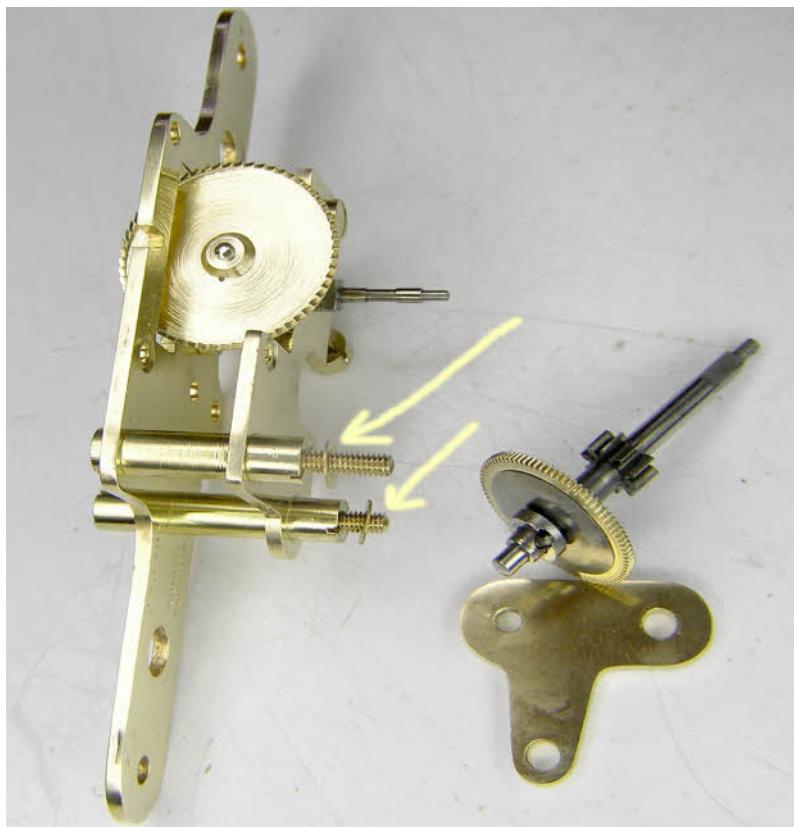
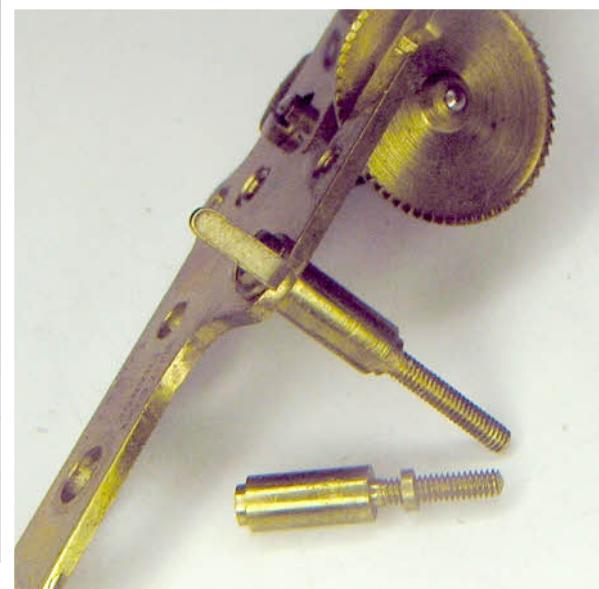
These two photos shows the three plated movement and the small spacing washers that can go missing so easily. Note also the centre wheel with the all in one cannon pinion, typical for the three plate movement.

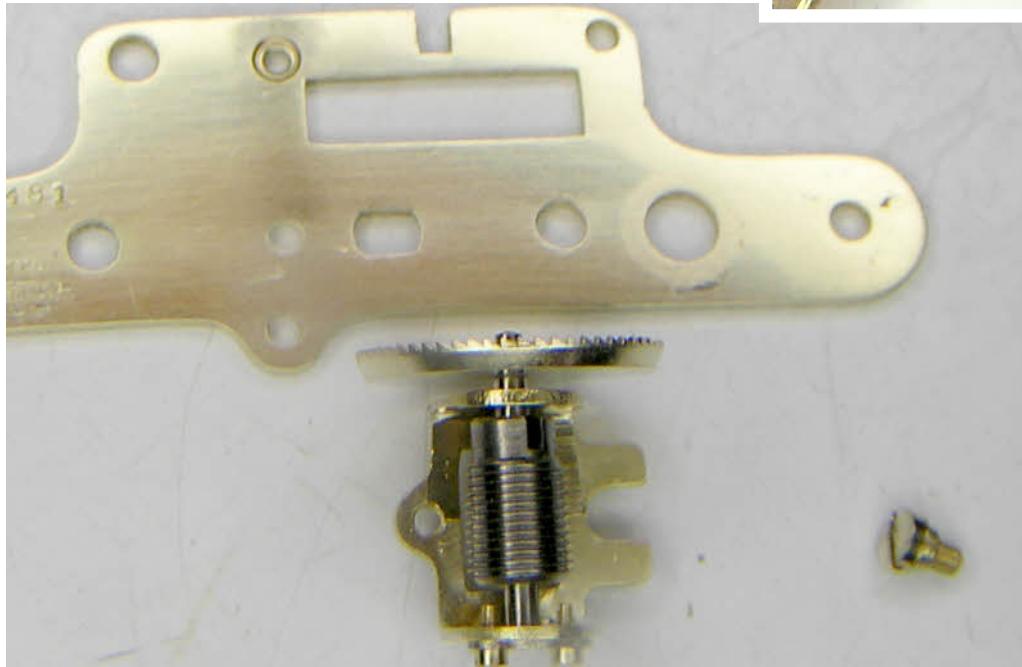
The count wheel and frame after cleaning and assembly. The worm must be completely free from dirt, grit and rust. Note the two small screws at the bottom that hold the hardened steel plate in position upon which the count wheel arbour rests and turns. Note also the elongated screw slots, one in the frame and the other in the count wheel plate. These facilitate the horizontal positioning of the worm in relation to the centre wheel..

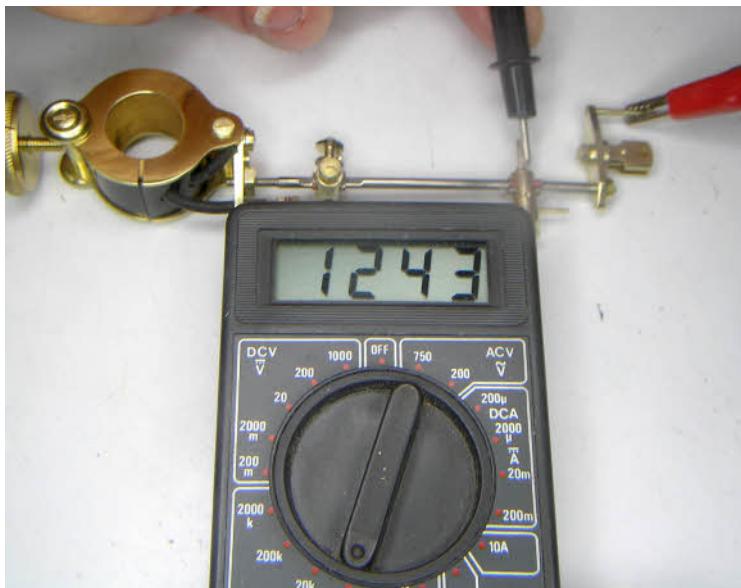
Testing the reassembled pendulum for shorts and continuity. It reads a healthy 1243 Ohms at the pin.

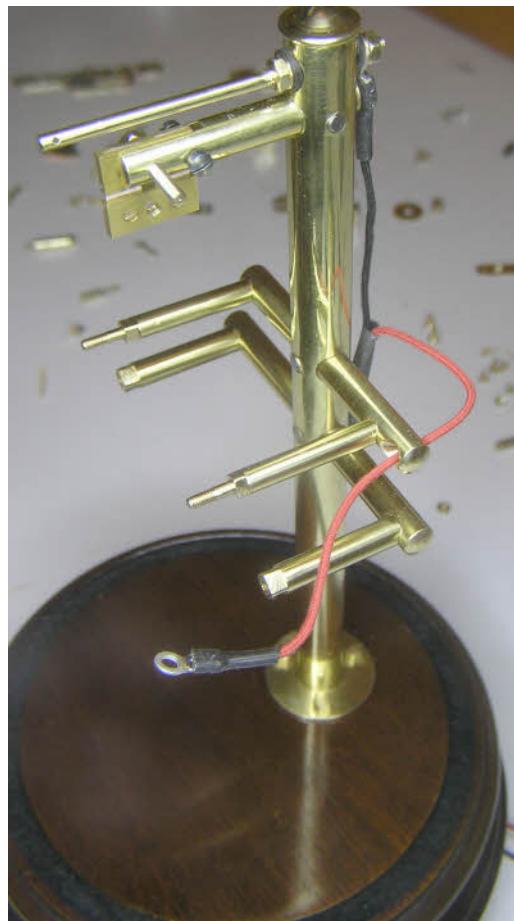
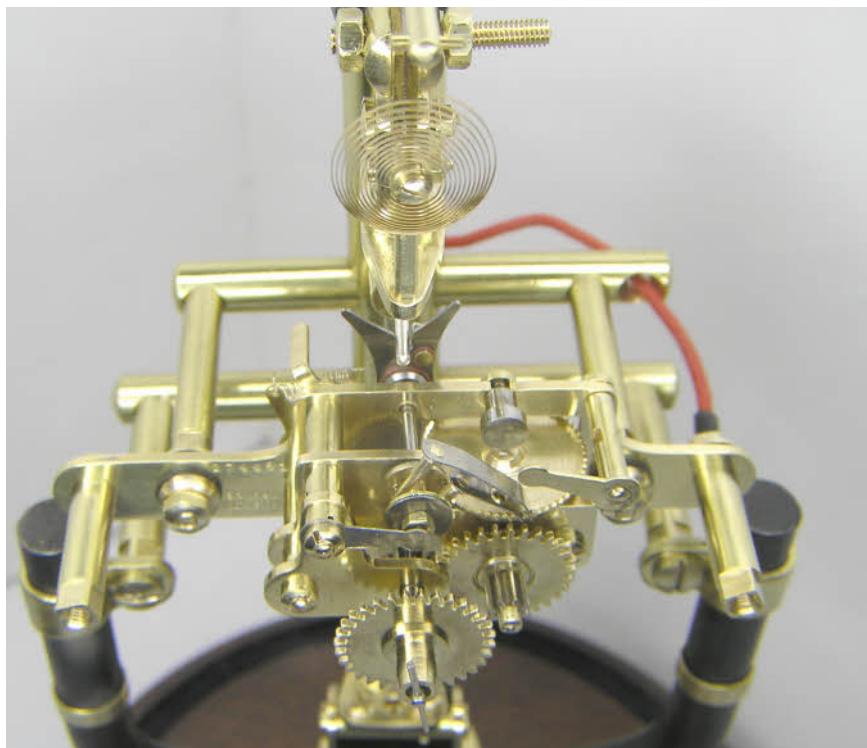
These last two photos show the frame and base reassembled with the new wiring and the finished movement in place.

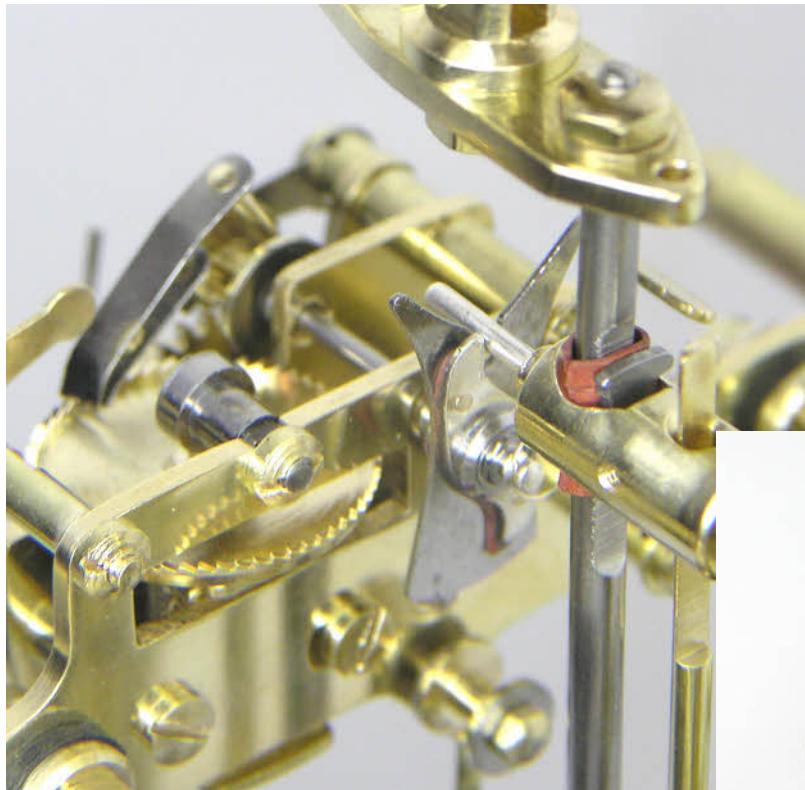
This photo at left shows the fork and pin in the optimal position. The action was also checked with a lens to make sure the silver contact on the fork was performing correctly at all points in the pendulum swing cycle.

The clock was left to run for 7 days and was within two minutes a week.

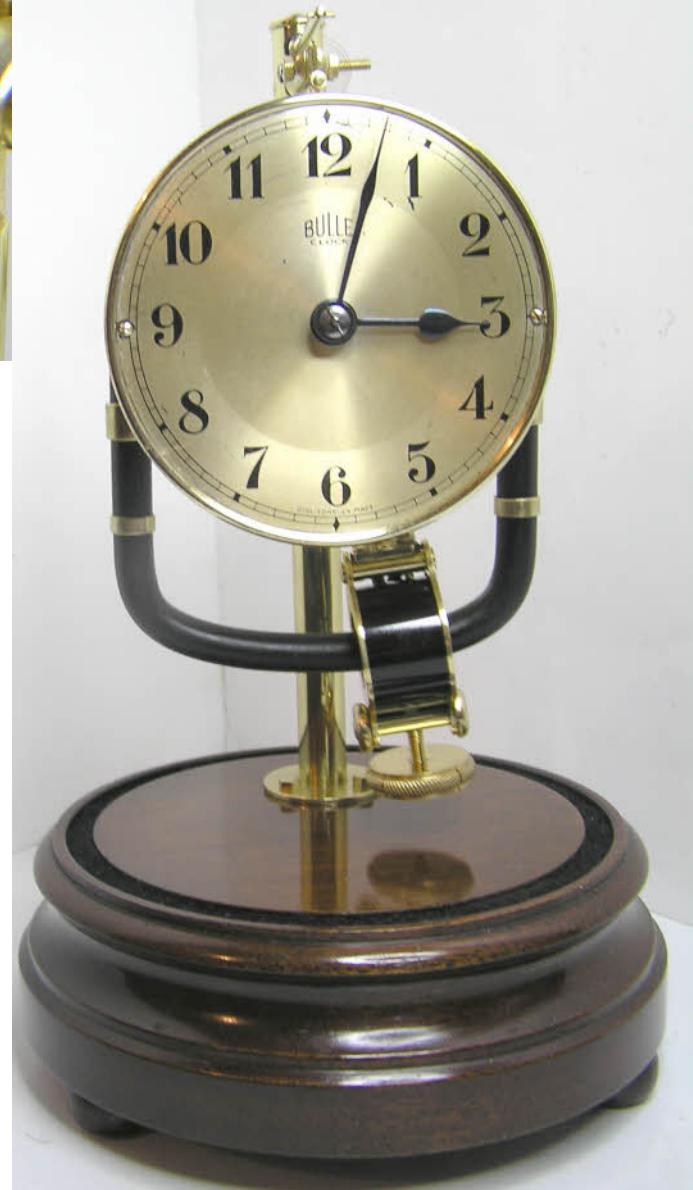
The finished clock
