The restoration of David Perret Wall Clock Serial No 2948

By Brian Scott brian@hectic.name January 2023

This article describes some of the history of David Perret clocks and the restoration by the Author of a wall clock by David Perret made around 1905.

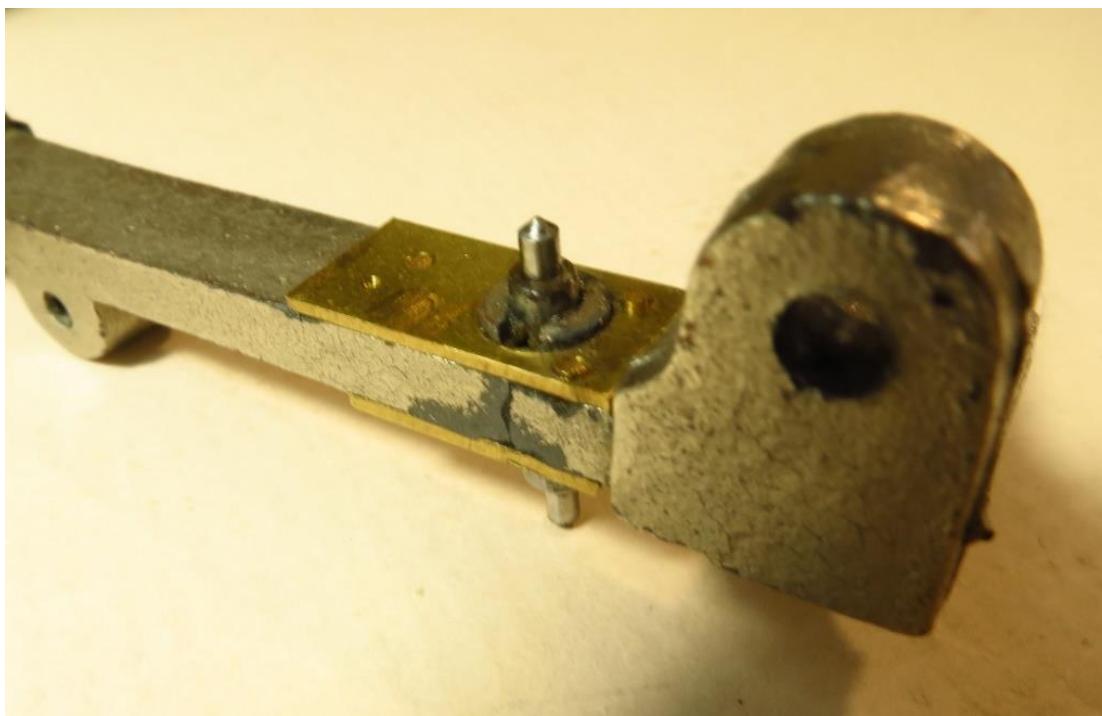
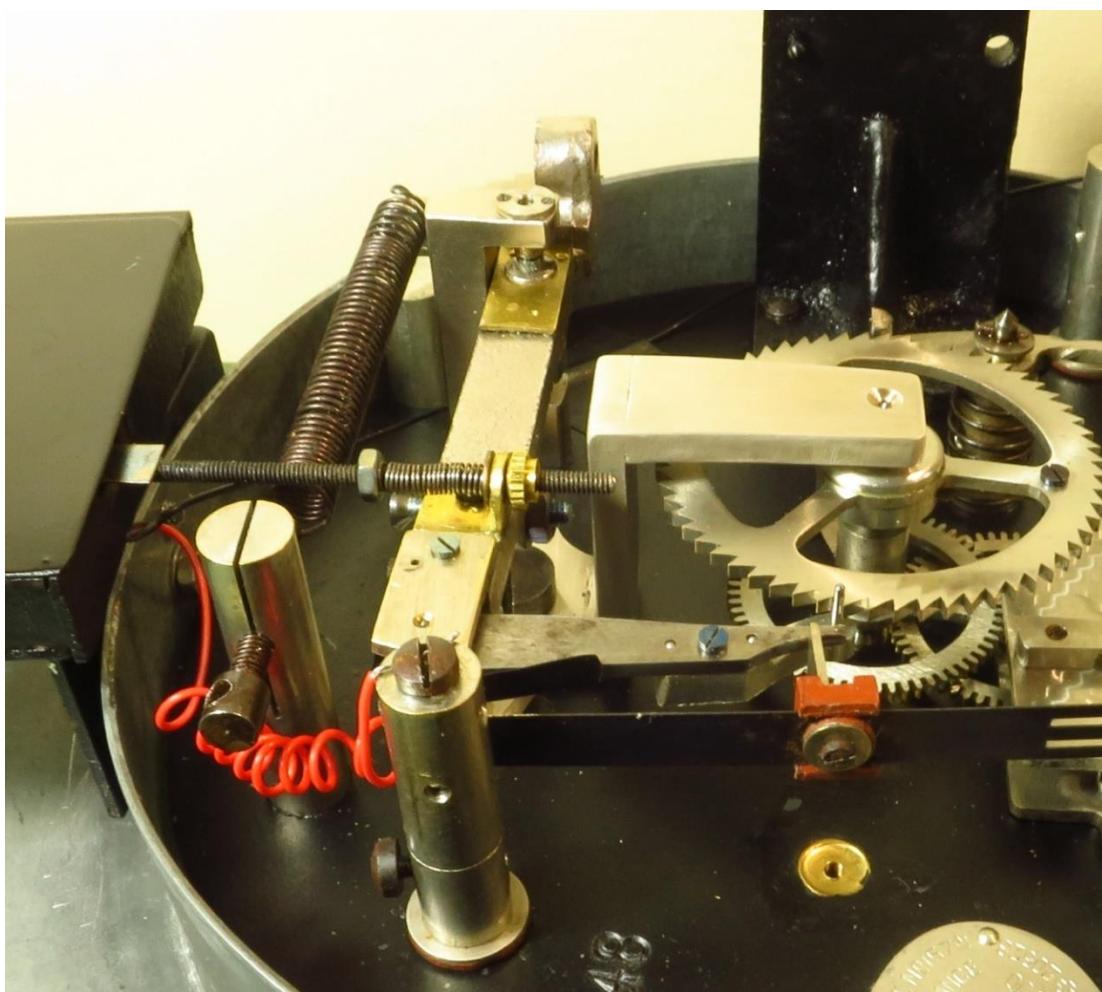
Initially the plan was to construct a new solenoid as it was thought that the solenoid would be of the twin coil type shown in the Patent sketches. However on closer examination it was found that the original solenoid had been the Iron Clad type (shown in the 2nd patent drawing) which would be a much more difficult task to construct. Additionally the repairs to the main solenoid operating beam, while quite well executed, were still a weak point with some serious cracks present. Given the ease with which the main support broke it was decided to utilise a more modern solenoid that would act on the opposite end of the beam – virtually eliminating the bending stresses at the main pivot point. While not ideal this solution eliminates the need to construct a new main solenoid operating beam and a new Iron clad solenoid. The new solenoid arrangement makes minimal alterations to the original components or the operating mode of the original clock.

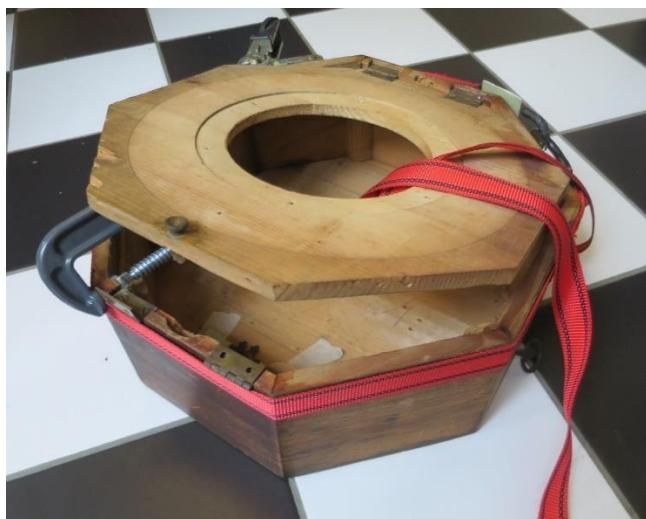
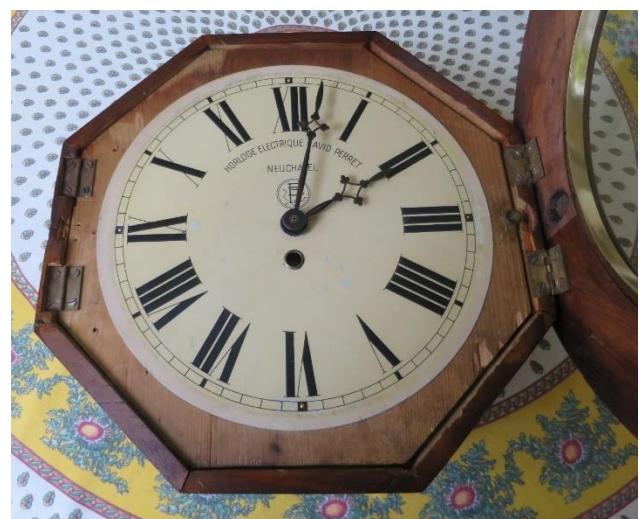
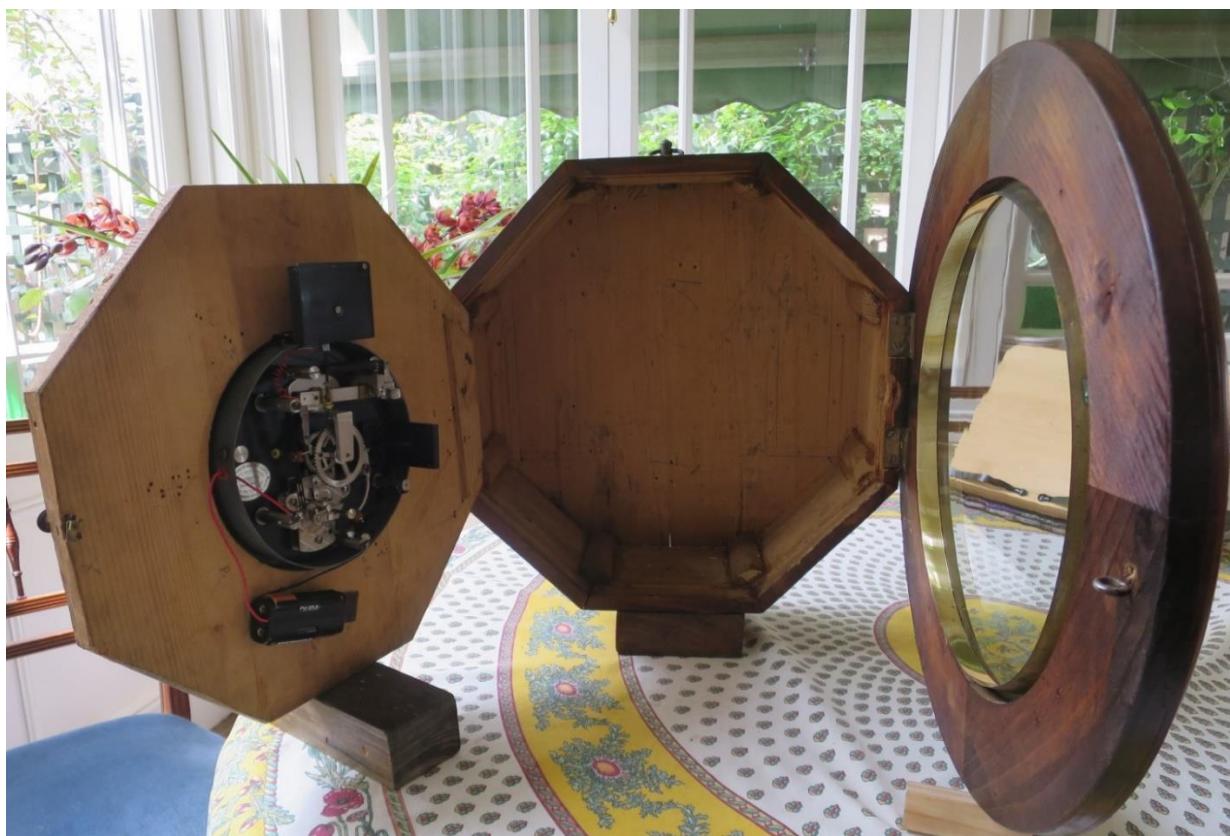
The original purchase did not include the clock case and it was expected that a reproduction case would have to be made. Miraculously a friend in France had a David Perret case which was fitted with a mechanical movement and he kindly donated the case. Presumably the original Perret movement failed and was discarded. The case was picked up from France in 2022. The case was a perfect fit for the movement and required no modifications. Some minor damage to the case occurred during transport to Australia. The case was repaired and restored, the movement fitted, the dial paintwork touched up and hands fitted. The winding hole made for the mechanical movement fitted when the original Perret electric movement failed was retained as a reminder of the clock's previous history. The clock has been running for over 170 days and apart from a small problem with a screw coming loose in the solenoid it has run well and keeps time to within a minute or two per month.
