CLASSIC BRITISH ELECTRIC ANALOGUE CAR CLOCKS

Part 2 Kienzle electric car clocks

(as fitted to "Classic" cars up to the late 1970s)

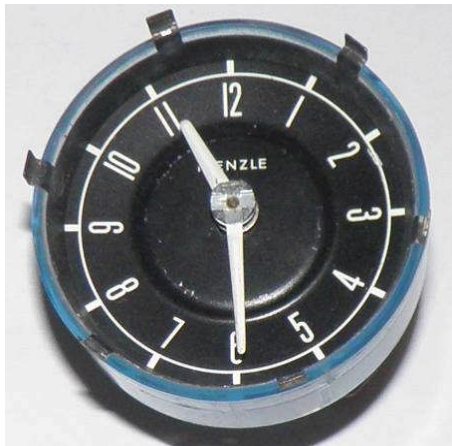
This clock is essentially a clockwork movement, the mainspring being "wound" electrically. The clock would only run for two to three minutes once electrical power was removed. This model of clock is self-starting. You may be able to hear the solenoid energising every couple of minutes. Regulation of these clocks was provided at the rear of the case, covered with a small piece of plastic tape or a date-code sticker. Adjustment was by way of a slotted shaft which accepts a small screwdriver. The works are retained in the case with three nuts at the back of the case, one of which also retains the "earth" terminal. Also note no second hand.

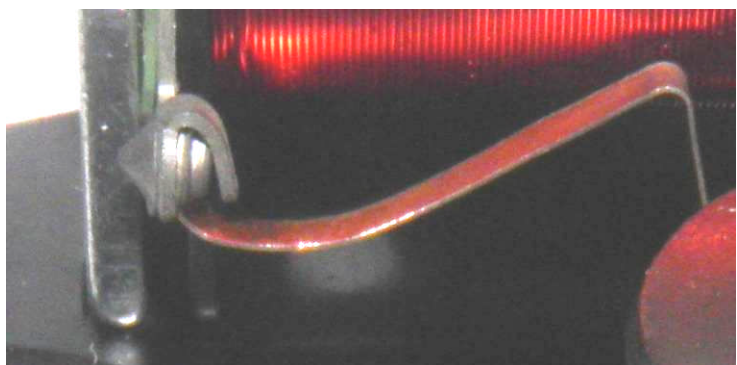
FIGURE 1.2: Magnified view of fusible links in Kienzle type 607 clock. Fusible link at left appears to have partially failed already. Right-hand picture shows an intact fuse assembly.

The following comments describe the thermal fuse, or fusible link, as found in these clocks. The fusible link on the left in *fig. 1.2* has partially failed and completely failed soon after this photograph was taken. Failure of this fuse link is attributed to insufficient tension in the pawl spring as noted in section 1.7. (Another type of excess current protection mechanism is shown in *fig. 1.16* at the end of this section.)

As shown in *fig 1.2* below, this fusible link **is not** a soldered joint. It comprises a connecting pin of low melting point alloy holding the spring-loaded terminals together. There is no evident "wetting" of these spring-loaded terminals as would be found in a true soldered joint. It appears this connecting pin is inserted through the two eyelet terminals and the shank is deformed by heating to retain the pin in place. The formed lug on the solenoid eyelet is then folded over the pin

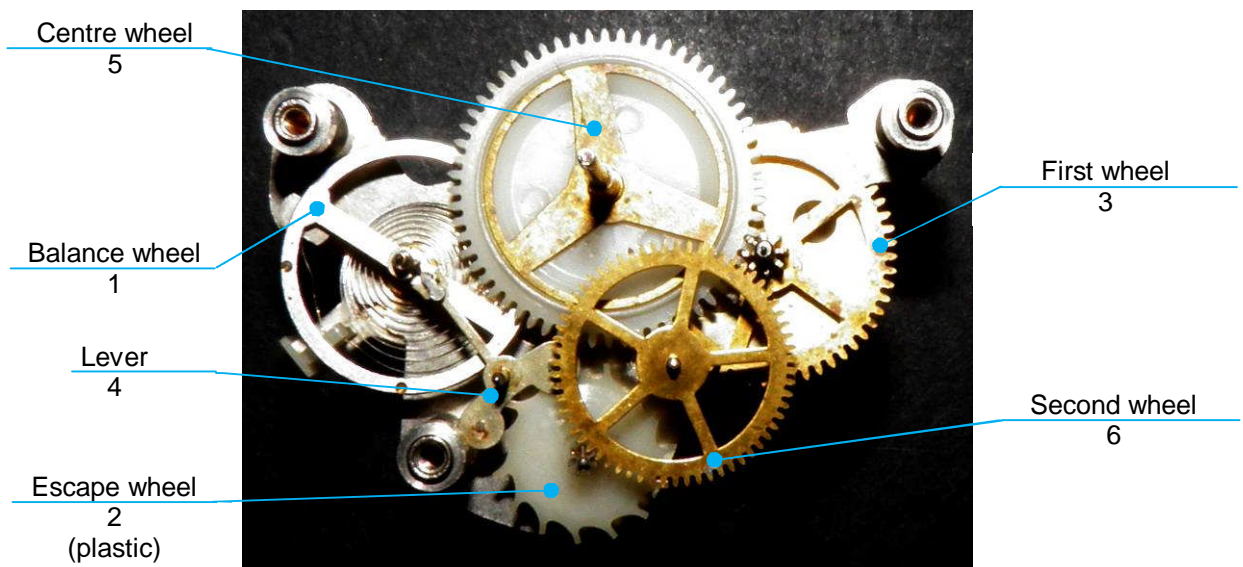
FIGURE 1.7: View of clock with front support plate removed. Numbers below each label indicate the order in which these wheels are replaced when reassembling the clock.

Fig. 1.7 below shows the partially disassembled clockwork mechanism. This is a standard clock works comprising a gear train, escapement and balance wheel type regulator. To clean, soak in isopropyl alcohol for an hour to soften any oil-bound dirt. Wash the parts with a small brush then peg all pivot holes (refer Appendix B) and rinse support plates. Clean all spindles and pivot journals with manila card or craft paper that has been wetted with solvent. If absolutely necessary, polish rough spindles with metal polish and thoroughly clean. Rinse parts and allow to dry. Note that the balance endshake adjusting screw will be locked with lacquer below the plate. Dip a cotton bud in nail polish remover or acetone and use to remove this lacquer.

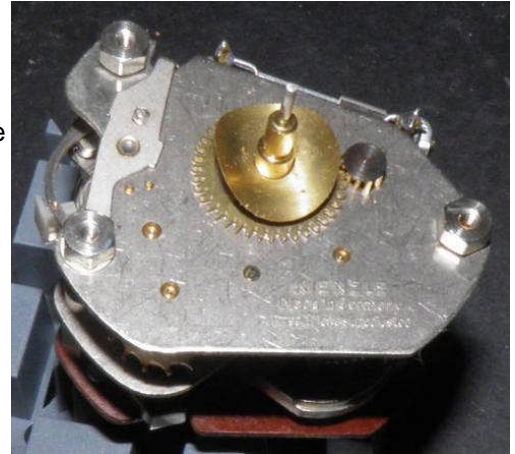
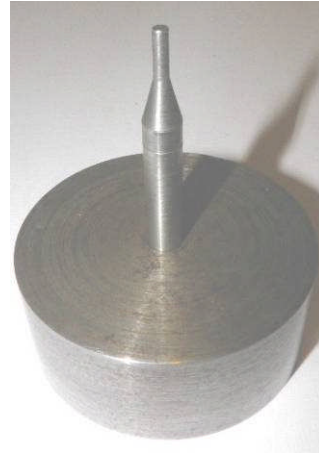
FIGURE 1.11: Assembled clock ready to fit to the case. The late dial assembly fits on top of this movement, the three protruding hexagon screw heads fitting into corresponding moulded sockets on the plastic dial backing/support plate. Older clocks have dial support plates attached to the top of these screws. (Refer fig. 1.14 below)

FIGURE 1.13: Cross sectional sketch of minute hand and boss showing the final position of the centre spindle (grey) within it. Photograph on right is a purpose-made anvil to support the centre spindle when fitting the minute hand assembly. (Refer Fig. 1.12 above.)

Secure the winding assembly with the three nuts. Check that the clock winds and runs when the clock is connected to a 12 Volt supply. Should it fail to run then find out why. If the winding mechanism "chatters" then recheck operation of the pawl and ratchet. Place the regulator quadrant at its mid-point. The clock works should now look like that in fig. 1.11.

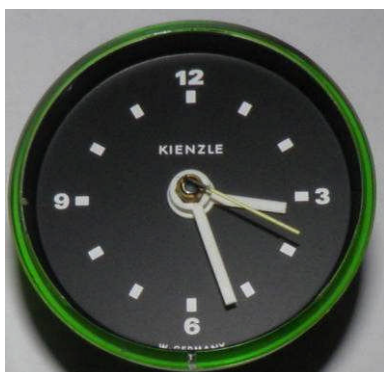
A later style of Kienzle clock, fitted with a second hand. This is a polarity sensitive (-ve earth only) clock and resembles that used by Smiths in their "CET/CTE" series clocks. In this clock the two coils are fitted to the circuit board and the magnets are incorporated in a balance wheel supported in two jewel bearings. Rather than hairsprings (Smiths CTE clocks had fixed magnets and coils on the balance with three hairsprings attached to the balance wheel to connect everything), these clocks are regulated by torsion in a helical coil spring. The electronic circuit used two transistors, one as a trigger device and another to provide the pulse to drive the clock mechanism, which is still a clockwork type mechanism. These clocks are self-starting.

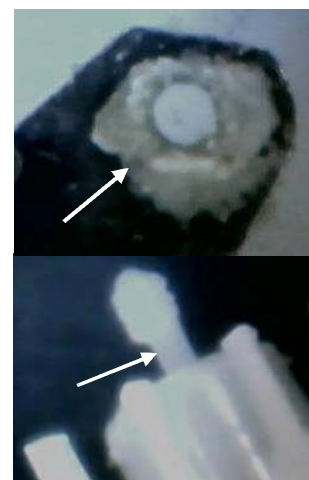
FIGURE 2.5: Showing damage (arrows) to impulse wheel pivot. Evidence of damage, the white plastic dust around the pivot hole (upper photo), was visible once the circuit board was removed from the clock assembly. The lower photo shows abrasion of the plastic pivot. There is not much you can do about this and the cause of this damage is not known for certain. So far this damage has been noted in one clock only.

There is a certain amount of side loading on this pivot and presumably this has caused the wear against an unlubricated (?) metal surface.

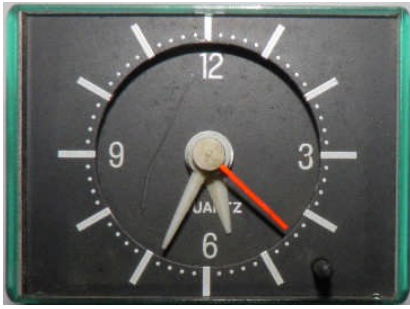
A typical quartz electronic clock. The electronics drive a simple Lavet-type stepper motor which drives the hands through a train of plastic gears. Analogue car clocks since the mid 1970s are of this type. Black pin (circled) at lower right is time-setting shaft, less pressed-on knob.

This particular unit is of unknown origin but is similar to clocks fitted to some Jaguar cars. These clocks are built to be replaced rather than repaired.
